**GAS PIPE LINE AT EASTCHURCH
ISLE OF SHEPPEY, KENT
MATTERS RELATING TO TREE HEALTH
PRELIMINARY REPORT
OCTOBER 1999**

PBA Consulting
5 Yeomans Way
Bournemouth
BH8 0BL
01202 816134

**GAS PIPELINE AT EASTCHURCH, ISLE OF SHEPPEY, KENT
MATTERS RELATING TO TREE HEALTH**

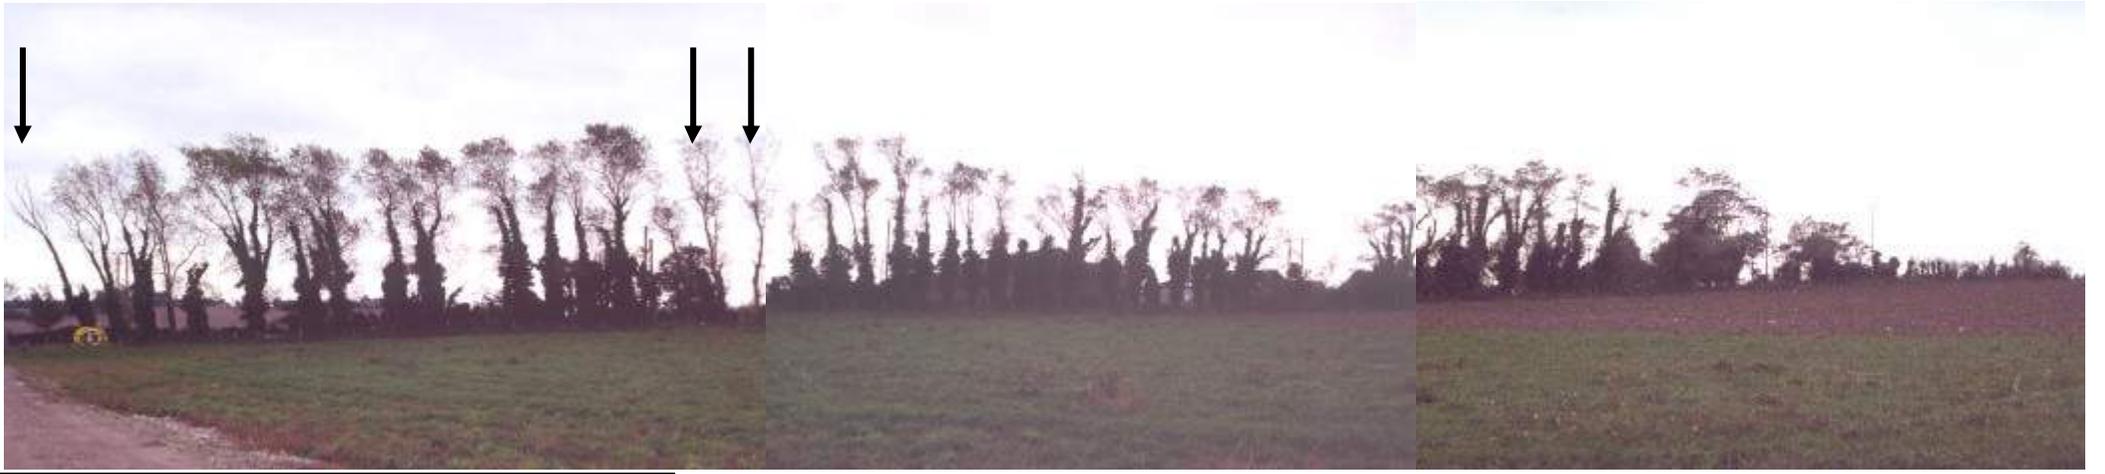
Photograph No1

Some 51 trees have been planted in a single row alongside the public highway along a distance of 218m at an average spacing of 4.3m. (See photograph No 1)

There are several gaps in the row of trees and there has been some gapping up with poplar whips (See Photograph No 2). There is a dead tree at the start of the section (One arrow, photograph No 1) and in one area, there are about four trees that have very low vigour (2 arrows, photograph No 1).

Commencing at the eastern end (i.e. from the farm track), the first tree in the row had a large basal cavity and was dead.

Of the fifty-one mature poplars, only five were considered to be affected by disorders that seriously affected vigour or were dead. These were at the east end of the section. The first tree was dead and a cluster of four trees was between 50m and 60m from the start of the section. These trees suffered from low vigour (even of the covering ivy), hollow stems, decay and moth infection.

Photomontage of row of trees with alleged damage
Dead tree and weak trees shown with arrows

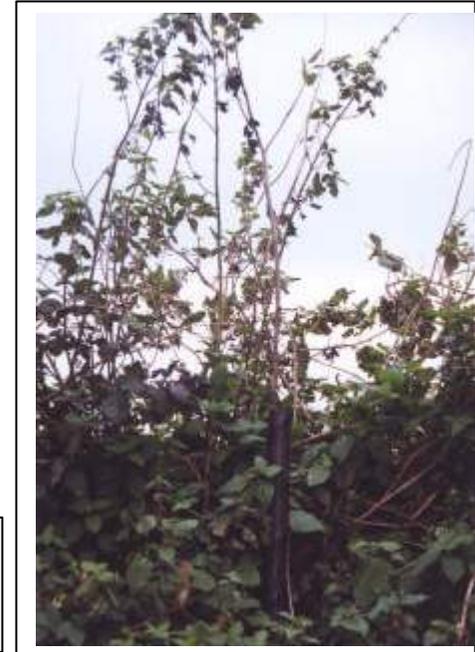
Photograph No 2

Whip planting to West of row

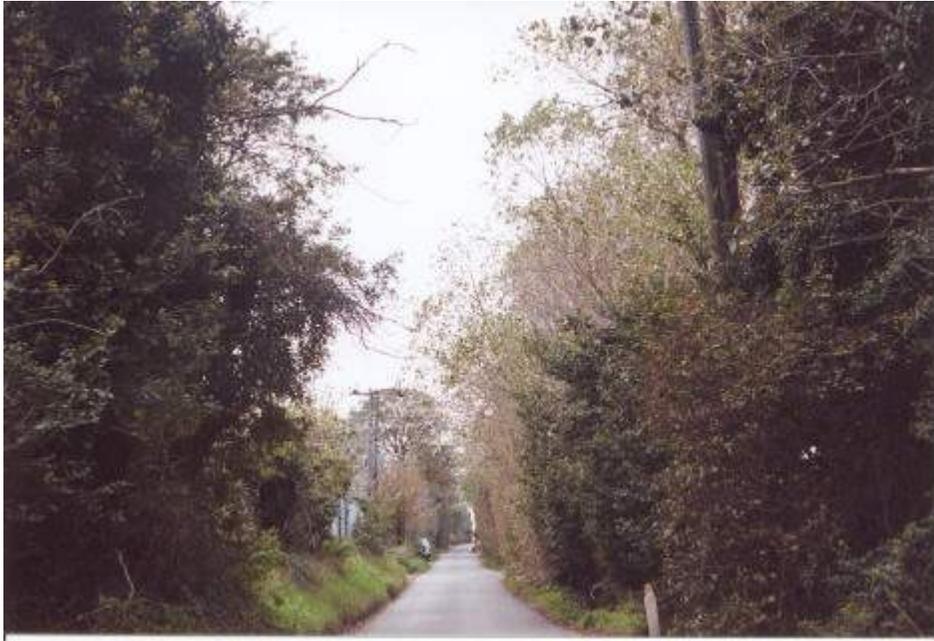
Photograph No 3

About mid-way along the row of poplar trees and for the rest of the row westwards, the overhead lines are aligned with the approximate southern part of the tree canopy. Along the full western length, the trees have been lopped so as to remove the southern half of the canopy (See photograph No 3).

Lopping of the south side of trees under power lines

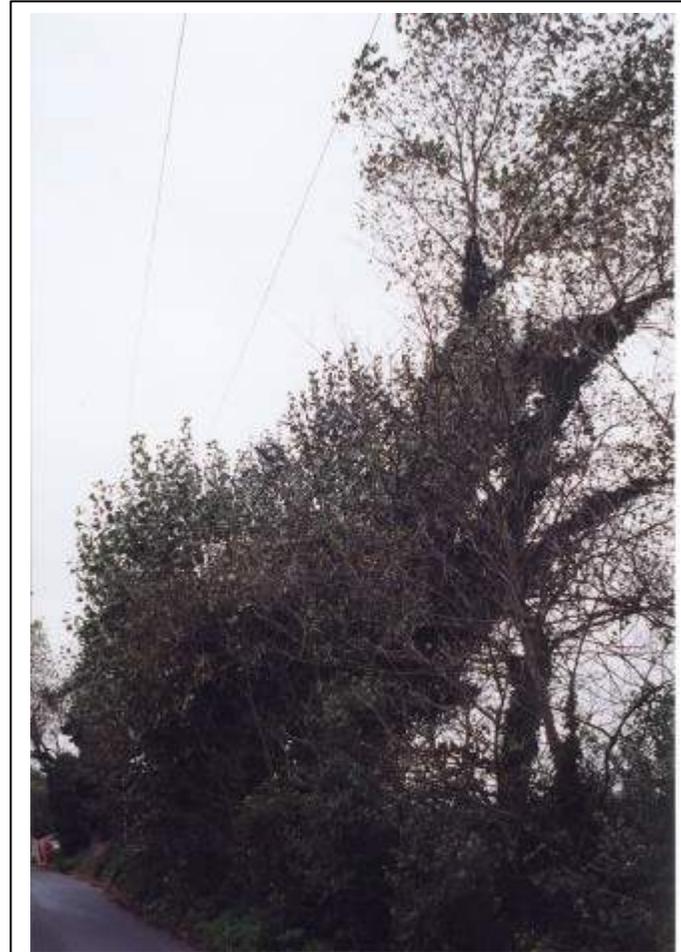
Photograph No 4

This lopping and trimming has had least effect in the eastern run of trees but has become severe in the western part where the trees are misshapen in the most affected area (see photograph No 4).

Mis-shaped tree caused by lopping to clear power line

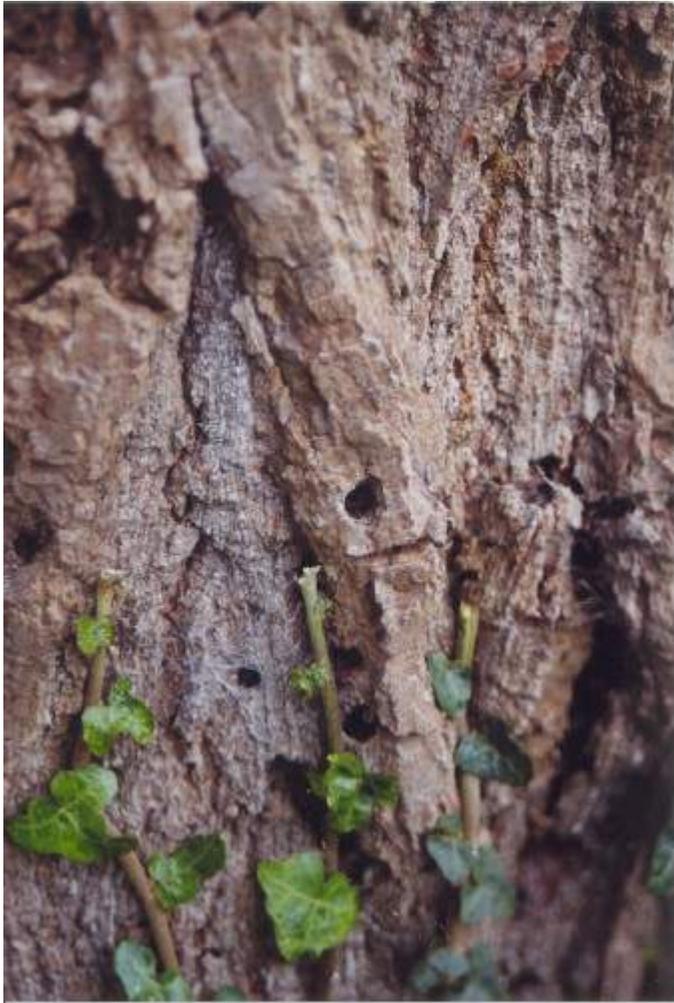
The base of most trunks where not obscured by dense ivy growths, was attacked by wood boring insects, probably Hornet Clearwing Moth *Sesia apiformis*. On some trees, these attacks appeared to be with a quite high density judging by the regular holes in the bark (See photograph No 5). These borings appeared on the lower part of the trees and on some extended to about 1.5 high. The extent of activity was difficult to see on many trees because of the strong ivy growth. There is a paucity of information on these moths and whether the attacks occurred because of low tree vigour or were a cause of low vigour has not been demonstrated.

Photograph No 5
Bore hole activity of Hornet Clear Wing
Moth

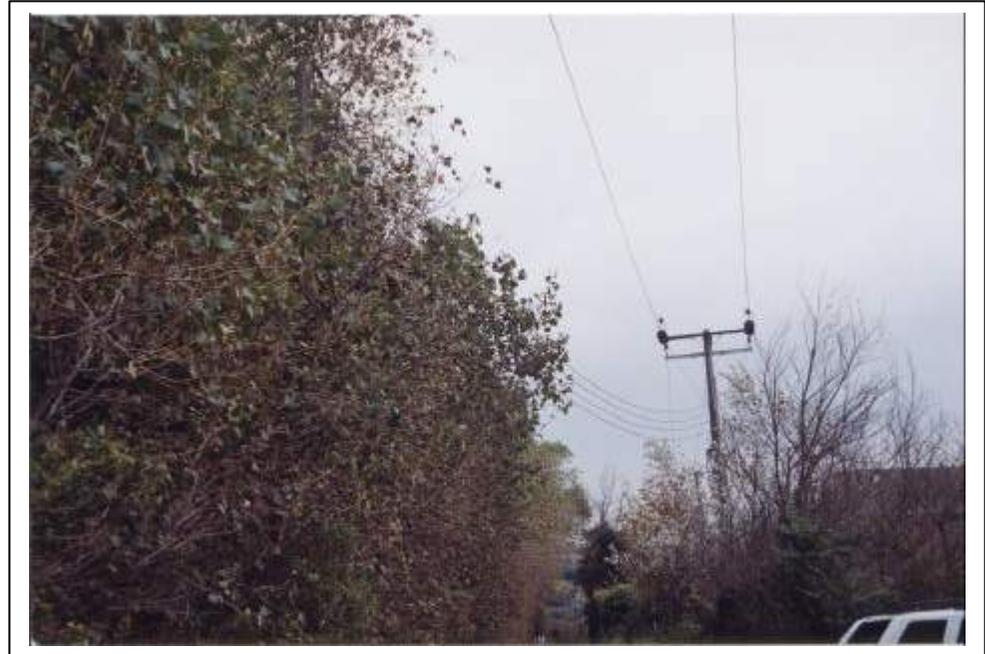
At 61m from the south end, the next poplar tree had been lopped at about 6m from ground level being immediately below the overhead lines. Covering ivy was very vigorous. This tree and the rest of the row all appeared healthy despite the lopping (See photograph No 6).

Photograph No 6
Healthy growth of trees in West
section

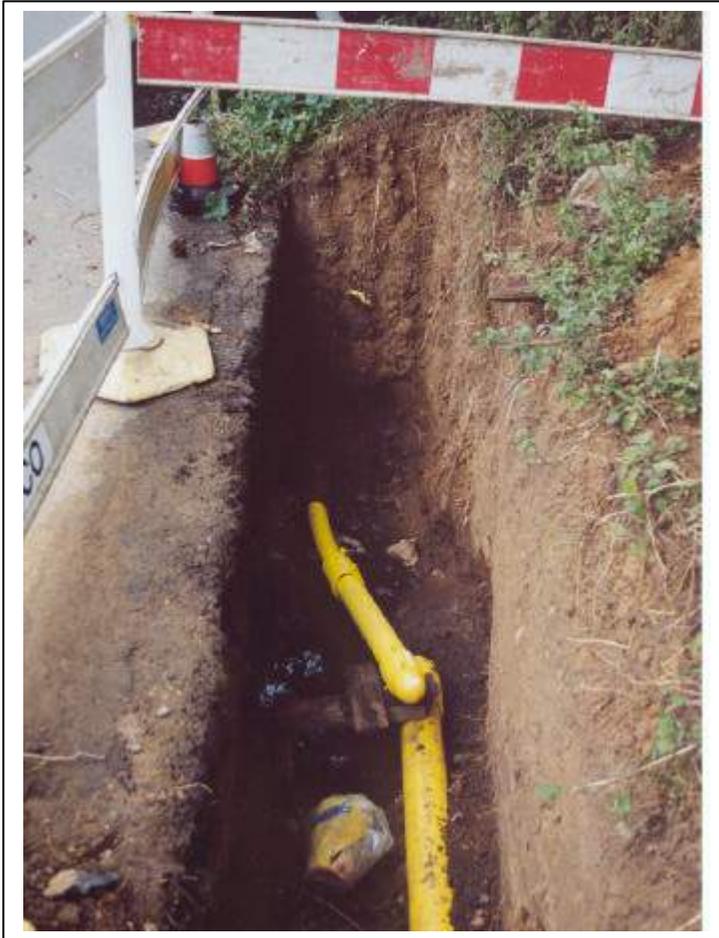
Soil Profile 1 in the lower trench(Photograph No 7)

Profile below healthy poplar tree with elm scrub between tree and soil face.

The soils are generally well drained and coarse loamy throughout.

A sample of soil was also taken from the undisturbed base of the trench adjacent to and from under the gas pipe. This was sent for an Atterberg test to ascertain its plasticity and the probability of tree roots causing subsidence damage to the gas pipe. The sample was confirmed as none plastic and therefore the roots would not cause subsidence damage. See Appendix A

There were no large (over 25mm) tree roots seen in walls of the trench although the pipe was surrounded by small fibrous roots, samples of these were sent for identification and were confirmed as emanating from poplar trees. See Appendix A

Trees adjacent to these soil profiles appeared to be in good health and the soil conditions were well drained and base rich and appeared to be well suited to poplar trees. Wind exposure was on the high side for poplars, but these trees were generally very vigorous in their growth pattern and exposure to high winds off the Thames Estuary appeared not to limit growth.

Photograph No 7
Lower trench from which soil and root samples were taken.

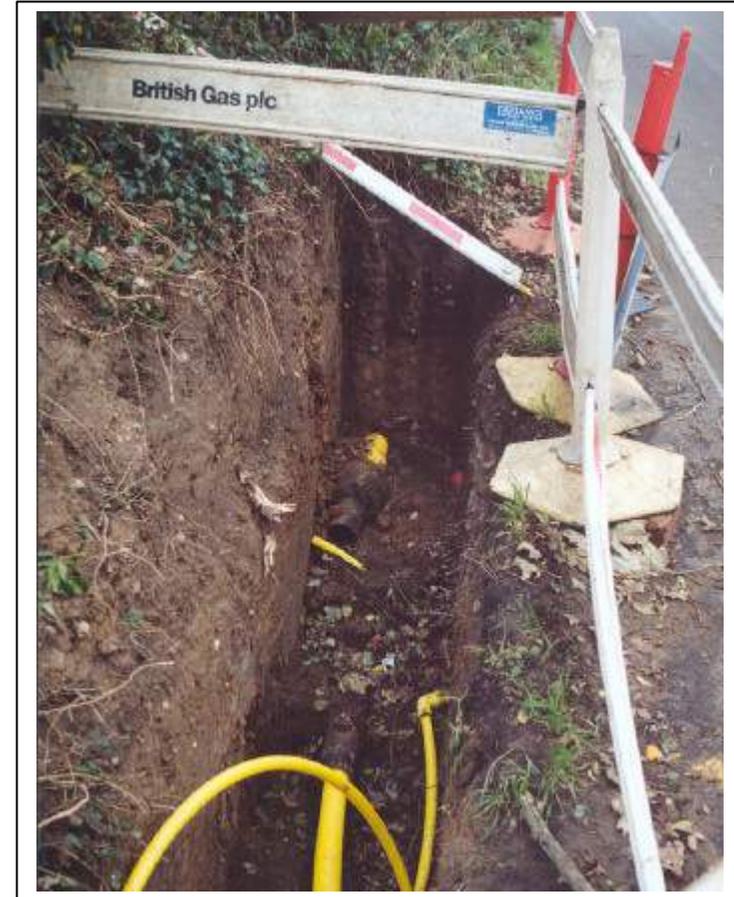
Soil Profile 2 in the upper trench (Photograph No 8)

Profile below healthy poplar tree with ivy and stinging nettle.
Described from side of exposed trench and therefore the soil is partly dried out.
Parent material is loamy Head.

Soil is affected by slight seasonal waterlogging below about 75cm depth and has coarse loamy over fine loamy. Part of the exposed profile may be fill from earlier trench backfilling.

A sample of soil was also taken from the undisturbed base of the trench adjacent to and from under the gas pipe. This was sent for an Atterberg test to ascertain its plasticity and the probability of tree roots causing subsidence damage to the gas pipe. The sample was confirmed as being of low plasticity and therefore the roots would not cause subsidence damage. See Appendix A

There were no large (over 25mm) tree roots seen in walls of the trench although the pipe was surrounded by small fibrous roots, samples of these were sent for identification and were confirmed as emanating from poplar trees. See Appendix A

Photograph No 8
Upper trench from which soil and root samples were taken.

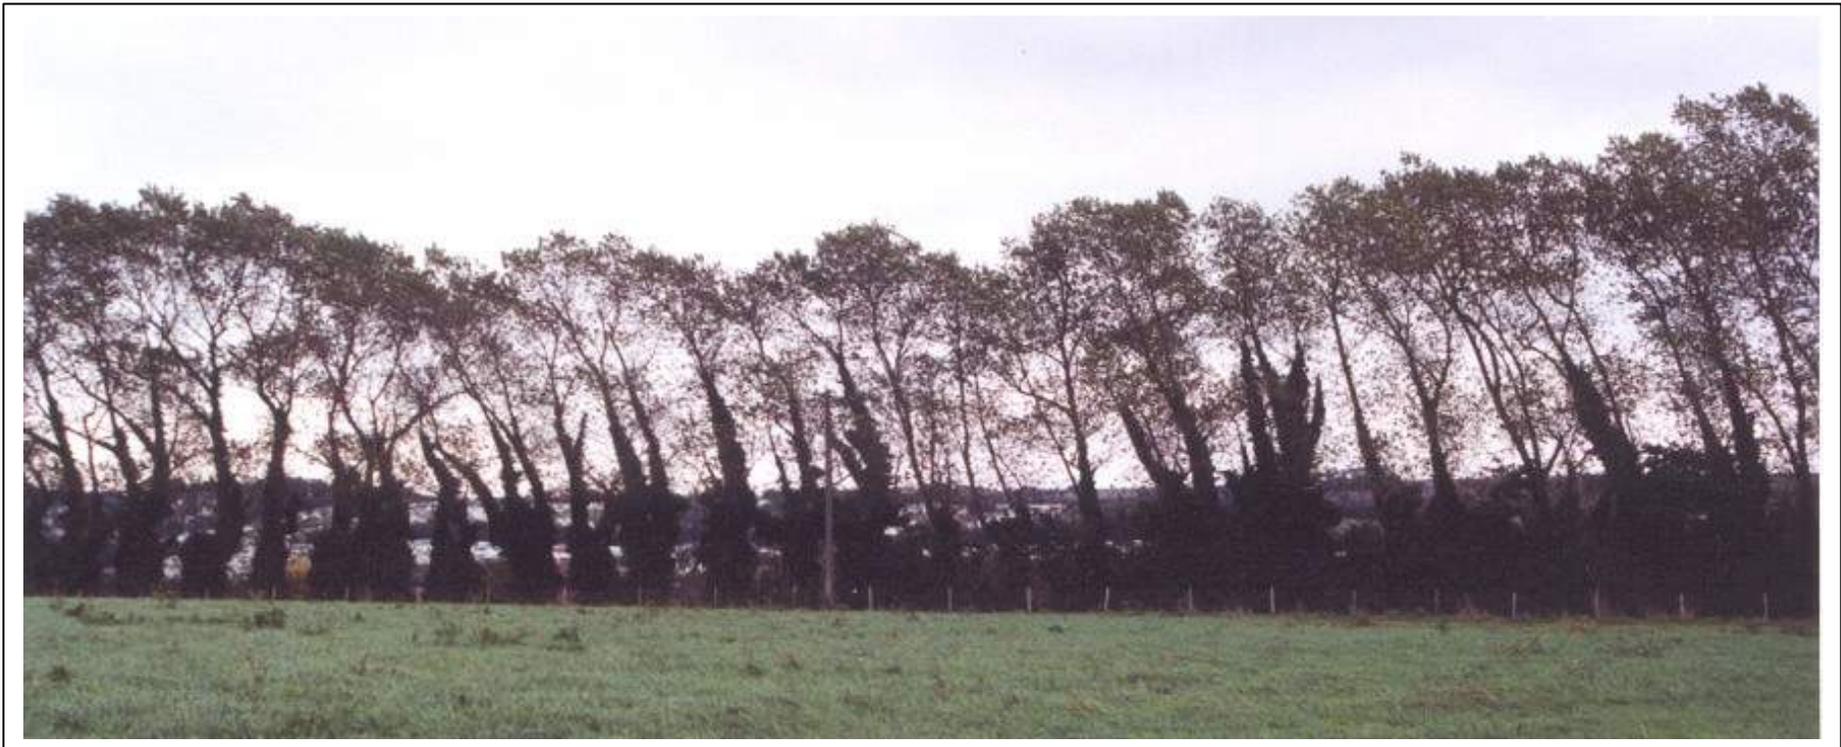
The owners of the adjacent farm, reported weak thin crowns of this row of trees when compared to the row of trees adjacent to the farm entrance track (See photograph 9). The weak thin crowns were probably the result of the lopping of branches below overhead lines. Other factors that may have affected the roadside trees and contributed to the thin crown effect and not the "control" trees include salt treatments to the road and soil cultivations over the root zone.

Photograph No 9
Row of trees adjacent to farm track
