## "Ground-Breaking Technology"

## Swedish Vasa Oak Warship

PBA Consulting is the first consultancy in the world to use TreeRadar GPR to investigate the internal condition of timber ship masts - this one was over 35 metres high! The investigation was in association with TreeRadar Inc. USA.

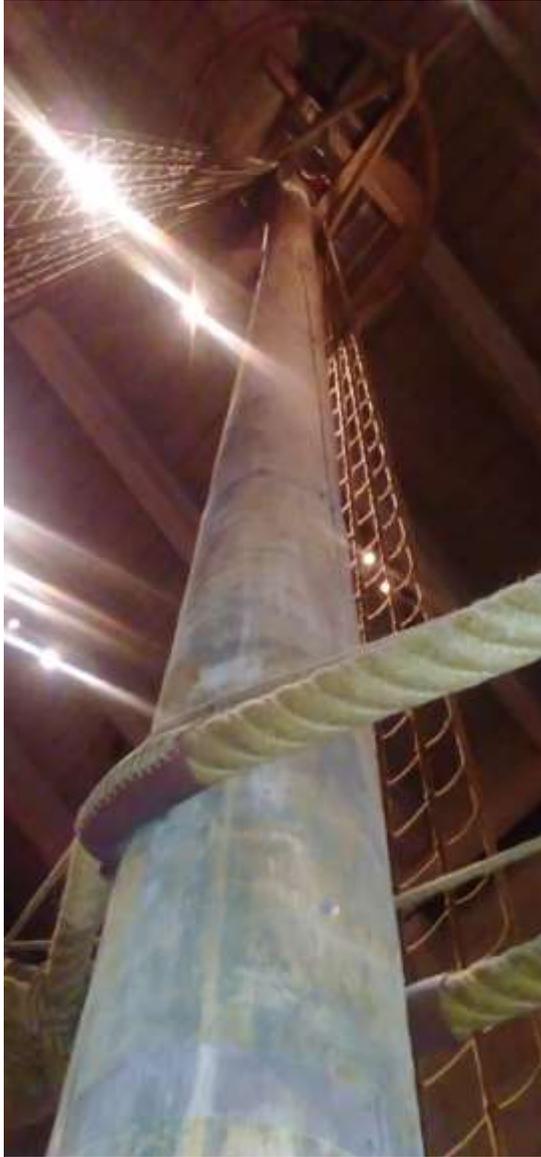
- Innovative use of TreeRadar (GPR) on huge mast.
- We wrapped it in Clingfilm!

The delicate surface of the mast had to be protected for the duration of the survey. PBA Consulting wrapped over 30 metres of this ancient mast in a protective layer of cling film. We worked from specially erected scaffolding.

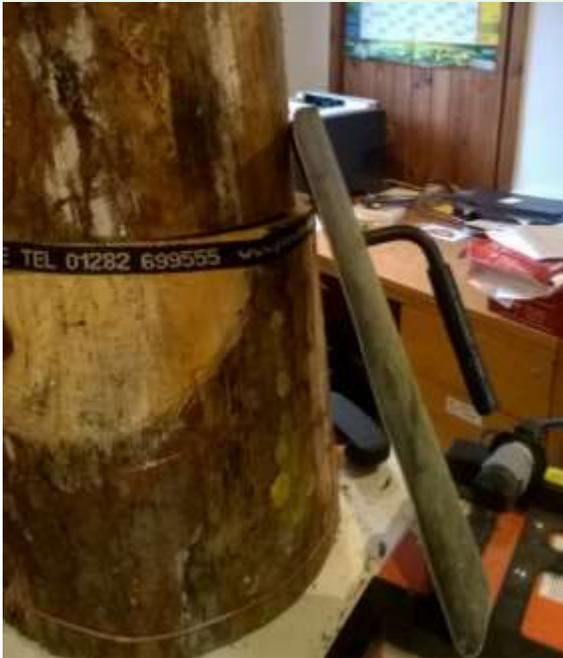
## Museum environment - low timber moisture values - bounced radar signals off metal plate

Being in the purpose-built Museum since the ship "left the seabed" in 1961, the mast moisture values were much lower than living trees and open stored timber. Therefore, the dielectric values of dry wood are close to that of air, the reflections back from the opposite (far) surface of the mast were weak. So a metal reflector plate was used to reflect back the signals to the GPR antenna. This enabled real-time speed analysis of the signal; internal refractives were enhanced. This assisted in the defining of the precise depth of timber for analysis.

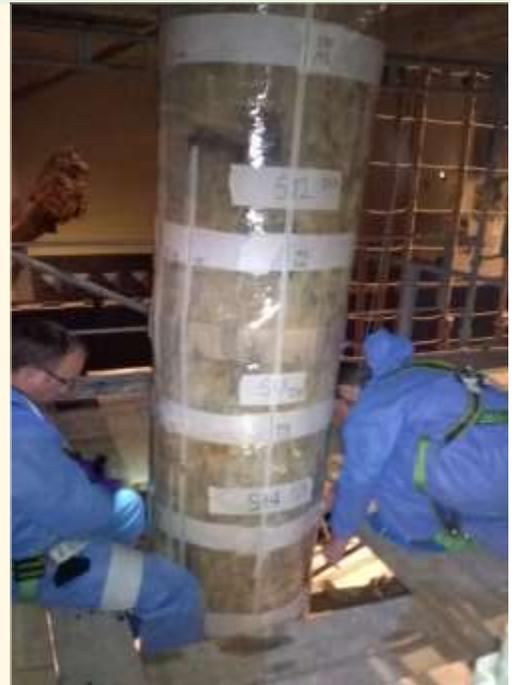
## 900 MHz antenna used - metal reflector plate held 180° to antennae during scanning process

Thirty cross sections were scanned over selected areas approximately 50 centimetres apart. At each location, a detail visual record of the external condition of the mast was made, entered into the database and plotted to the massive pole on masking tape. The information included cardinal points compass, significant cracks and other features. The plotted data was electronically tagged during the scanning process to assist the analysis process. These tags are shown as green dotted lines on the cross-sectional visuals and were an aid to analysis and in correlating information back to the mast.
